Waterproofing Systems

## Horizontal barriers against rising damp in masonry

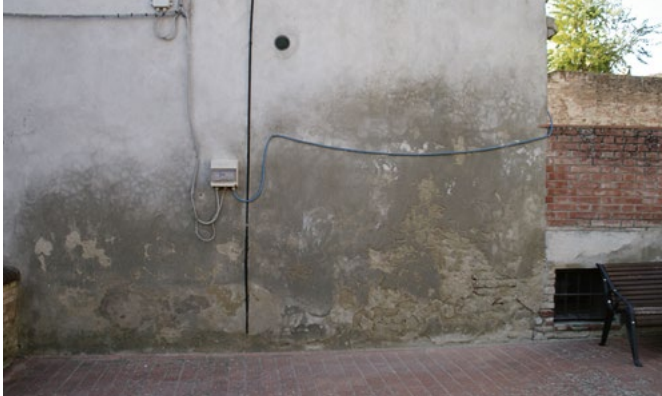
Change of color, reduction of the thermal insulation

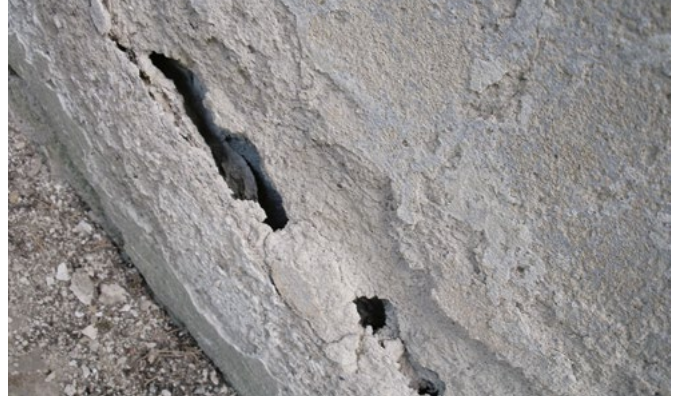
Damaged plaster

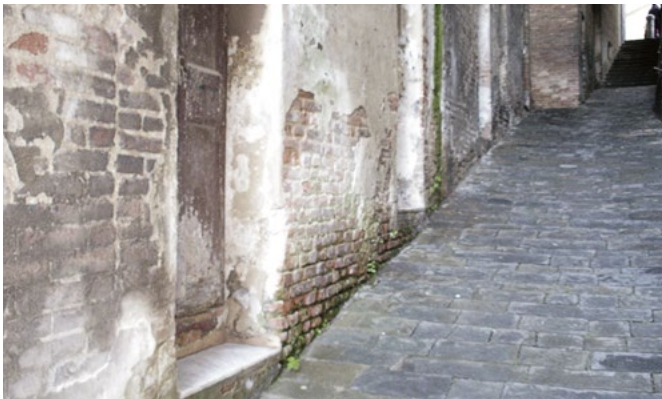
Destruction of render and mortar joints

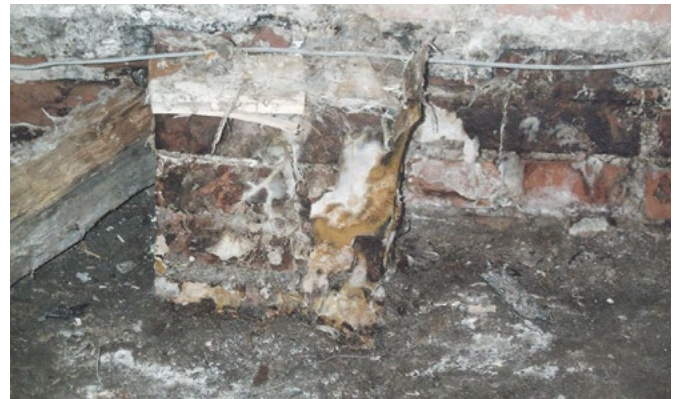
Development of mold and damage to the fabric of the structure

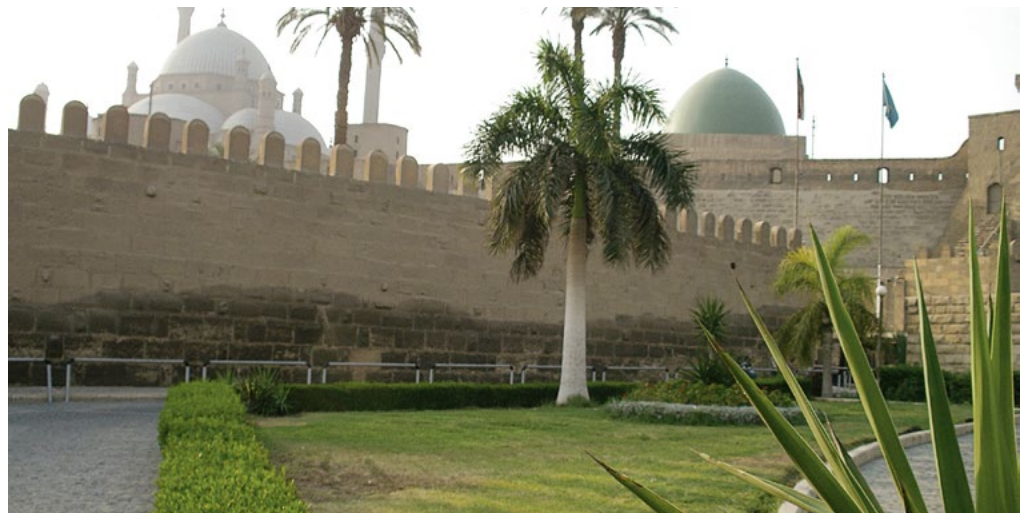
Example of rising damp

Building materials like bricks absorb water in a similar way to a sponge (see photo). This occurs because masonry, as well as concrete contains small pores. Depending on the diameter of the pores, they can transport water upwards against gravity (rising damp). Pores with a radius between 0.0001 mm and 0.1 mm show the most distinctive water transport and are referred to as capillaries. Between 20 % and 50 % of the pores in building materials like concrete, brick, and mortar fall into that category. Pores with a radius below 0.0001 mm are called „micro pores“ and are too small for capillary water transport, whereas pores with a radius above 0.1 mm are too large.

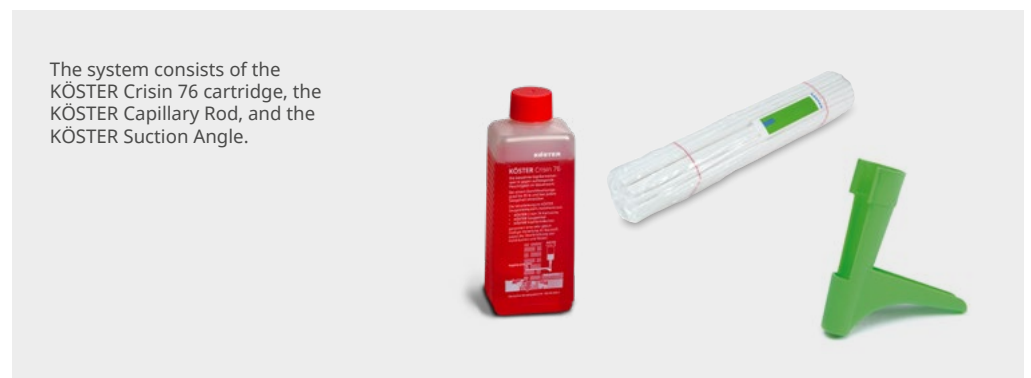
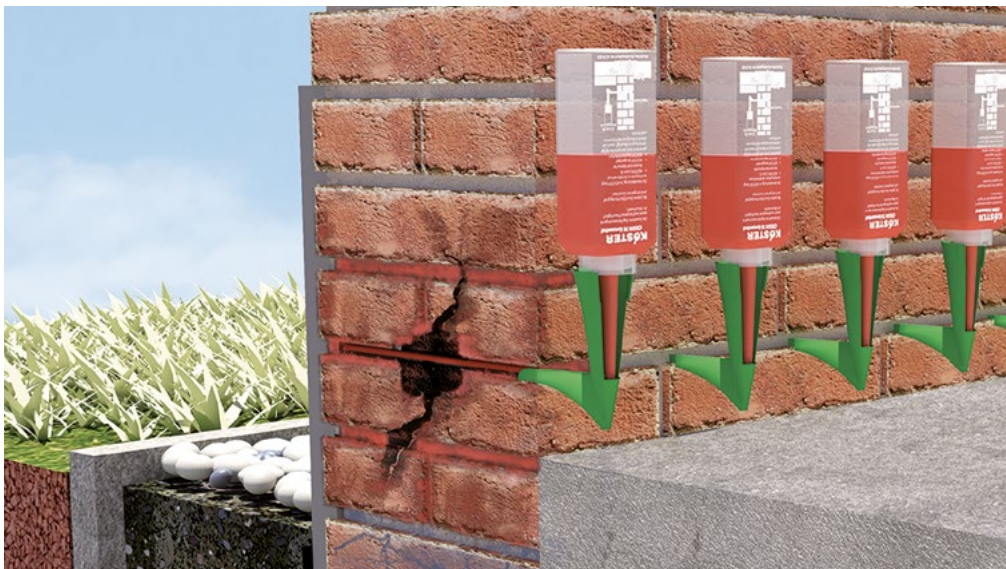
### The patented KÖSTER Suction Angle System:

The KÖSTER Capillary Rod acts like a wick, one end is inserted into the wall and the other end into the KÖSTER Suction Angle. From there, it draws the injection liquid into the wall. The KÖSTER Capillary Rod is available in lengths of 45 or 90 cm.

Schematic representation. Actual circumstances may differ in reality.

The patented KÖSTER Suction Angle System is the result of decades of experience and development work by the KÖSTER BAUCHEMIE AG. The horizontal barrier is distributed through the capillary transport itself, stopping the rising damp with its own physical cause.

This is a crucial advantage not only when installing horizontal barriers into hollow bricks, vertically perforated bricks or old and cracked masonry, but also for all other conditions. The method is clearly visible and allows easy control of the distribution of the injection material into the wall. It also gives security in the cost calculation for the installation of a horizontal barrier since the amount of material needed can be easily and accurately determined (the flow of the material is achieved through the rods and therefore there is no possibility of material run off).

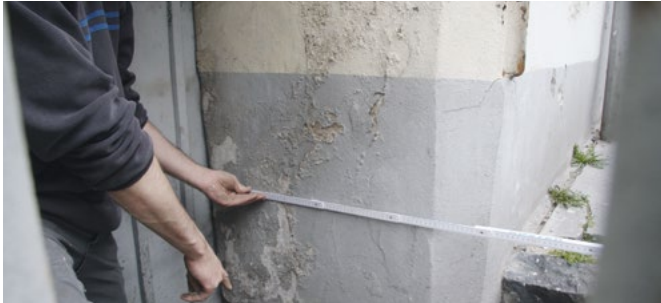
1 The salt and moisture contents are high in the masonry, the existing plaster is damaged.

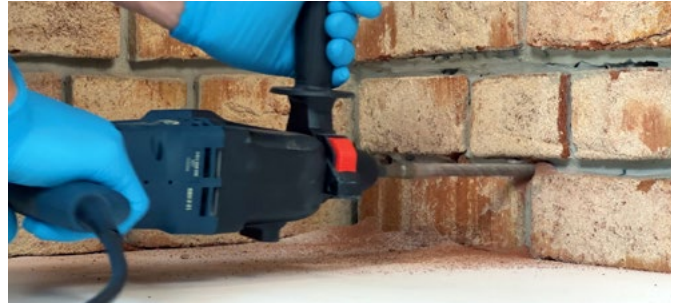
2 Boreholes are drilled into the inner wall with a distance of 10 cm from one another and depth of 40 cm (Wall thickness: 45 cm and 30 cm above grade).

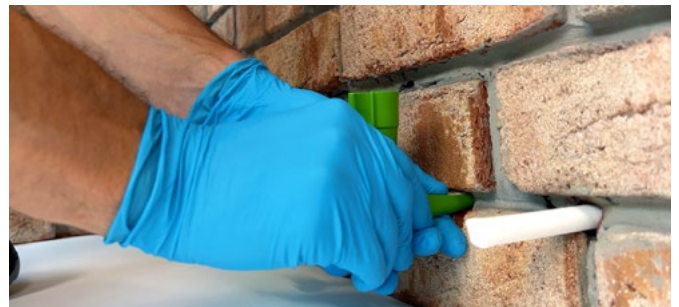
4 KÖSTER Capillary Rods are installed so that they protrude 7 cm from the borehole.

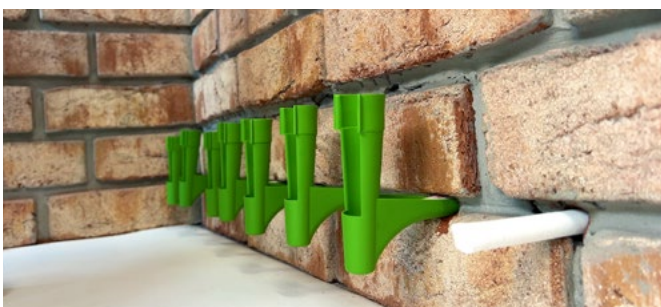
5 The KÖSTER Suction Angles are installed so that the KÖSTER Capillary Rods reach into the supply chamber of the KÖSTER Suction Angles.

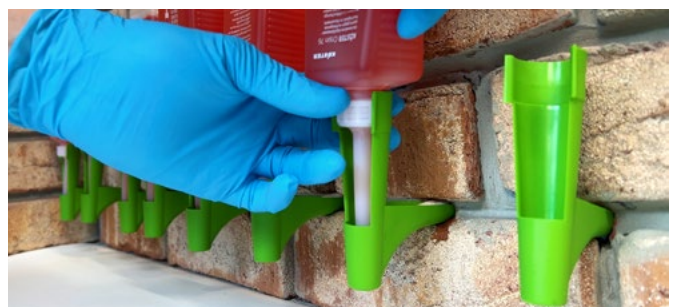
6 The KÖSTER Crisin 76 cartridges are then installed into the KÖSTER Suction Angle.

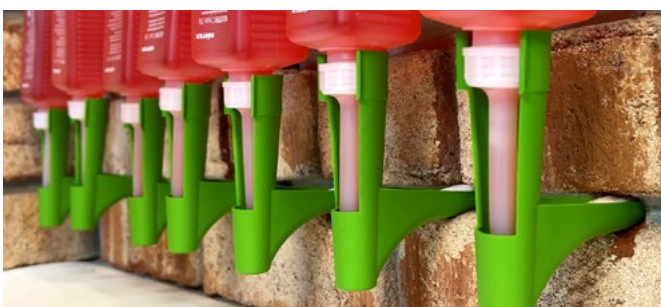
7 The nozzles of the cartridges sit directly on top of the capillary rod and allow the material to be soaked up.

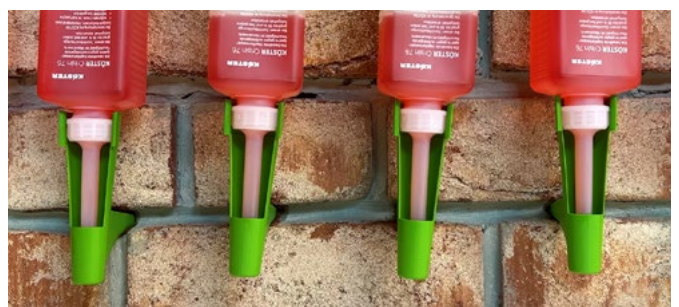
8 The pressureless injection of KÖSTER Crisin 76 into the masonry starts immediately after the installation of the cartridges.

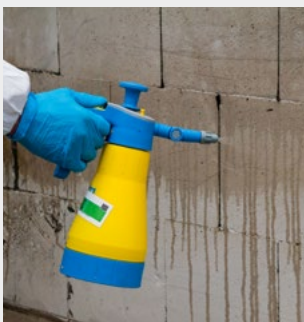
Remove old plaster. Spray KÖSTER Polysil TG 500 onto the surface to block salts and harden the substrate. Fill breakouts and holes with a KÖSTER Repair Mortar.

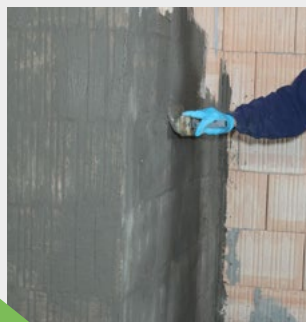
If negative side waterproofing is necessary, KÖSTER NB 1 Grey is applied in two layers.

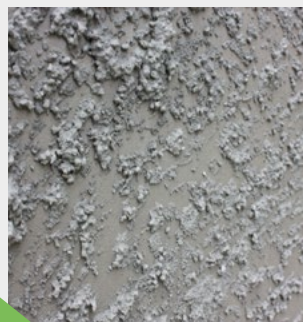
In the next step KÖSTER Restoration Plaster Key is applied to ensure the optimal adhesion of KÖSTER Restoration Plasters.

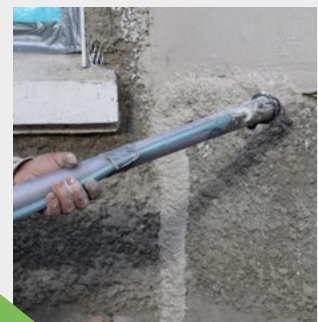
The KÖSTER Restoration Plaster is applied with a trowel or an appropriate mortar pump on the cured layer of KÖSTER Restoration Plaster Key. In the last step the surface is floated smooth.
